INVESTIGATING COMMITTEE REPORT
OF EXPLOSION AT K-25

KS-379

Location of Incident: Building K-413, Carbide and Carbon Chemicals Company, K-25 Plant, Oak Ridge, Tennessee.

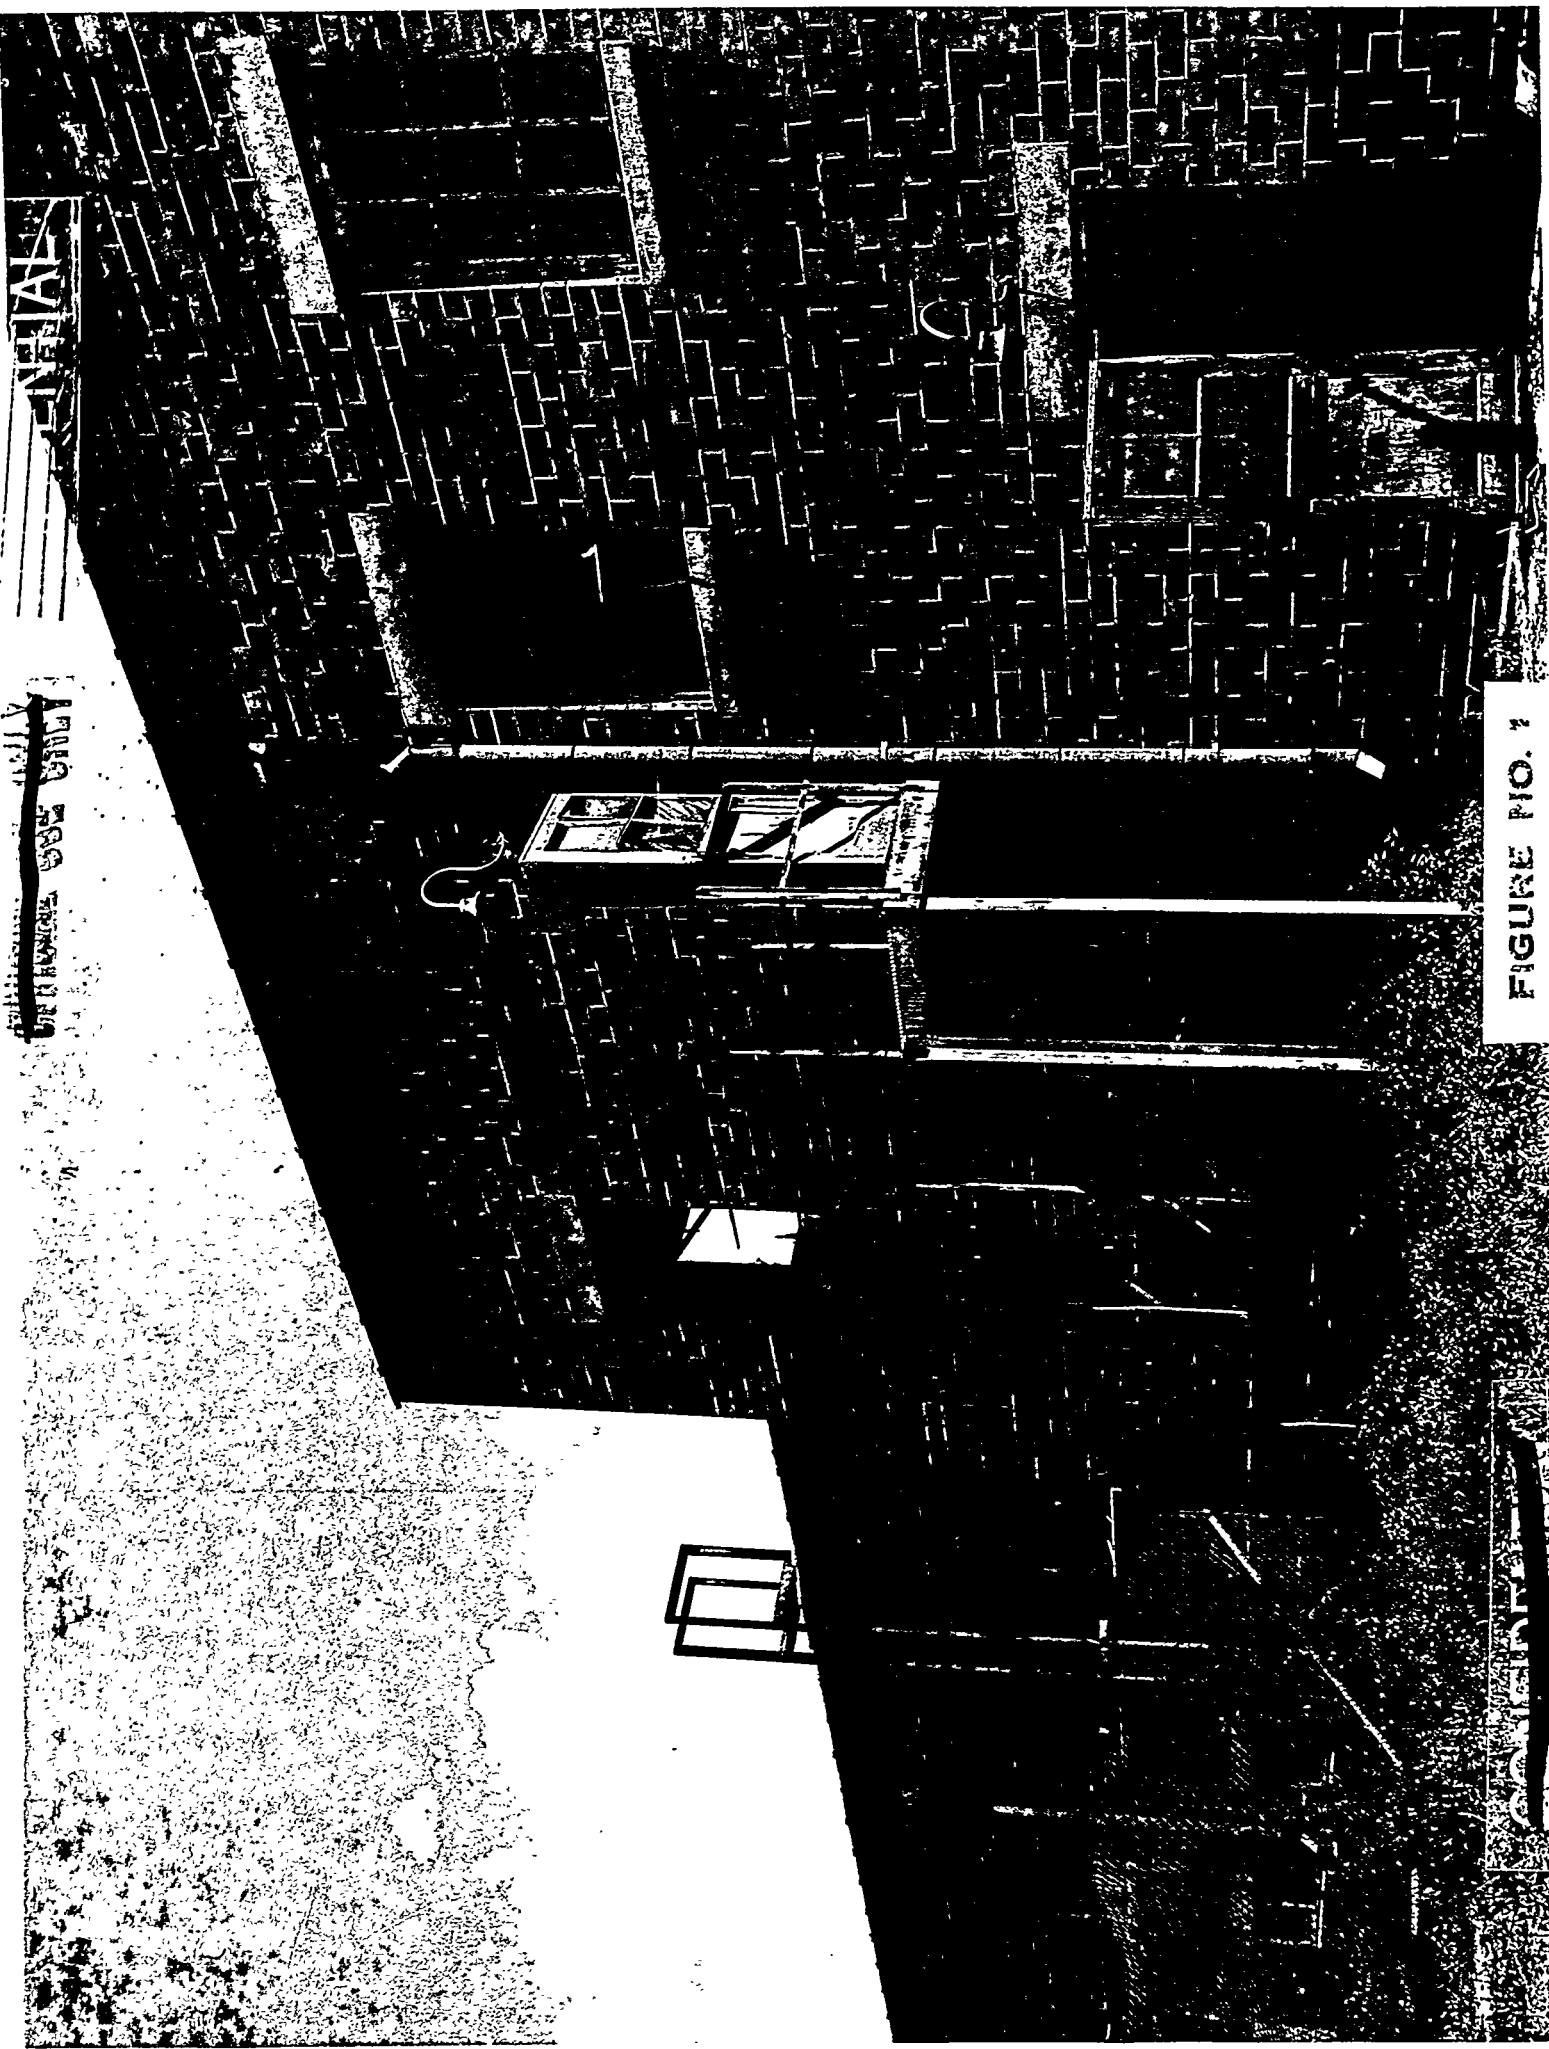
FIGURE NO. 1

5. The violence of the explosion is attested by the attached photographs which are identified as follows:
 - a. Photograph No. 1. Outside of the building. The third employee was working at a point beyond the lower left edge of the photograph.

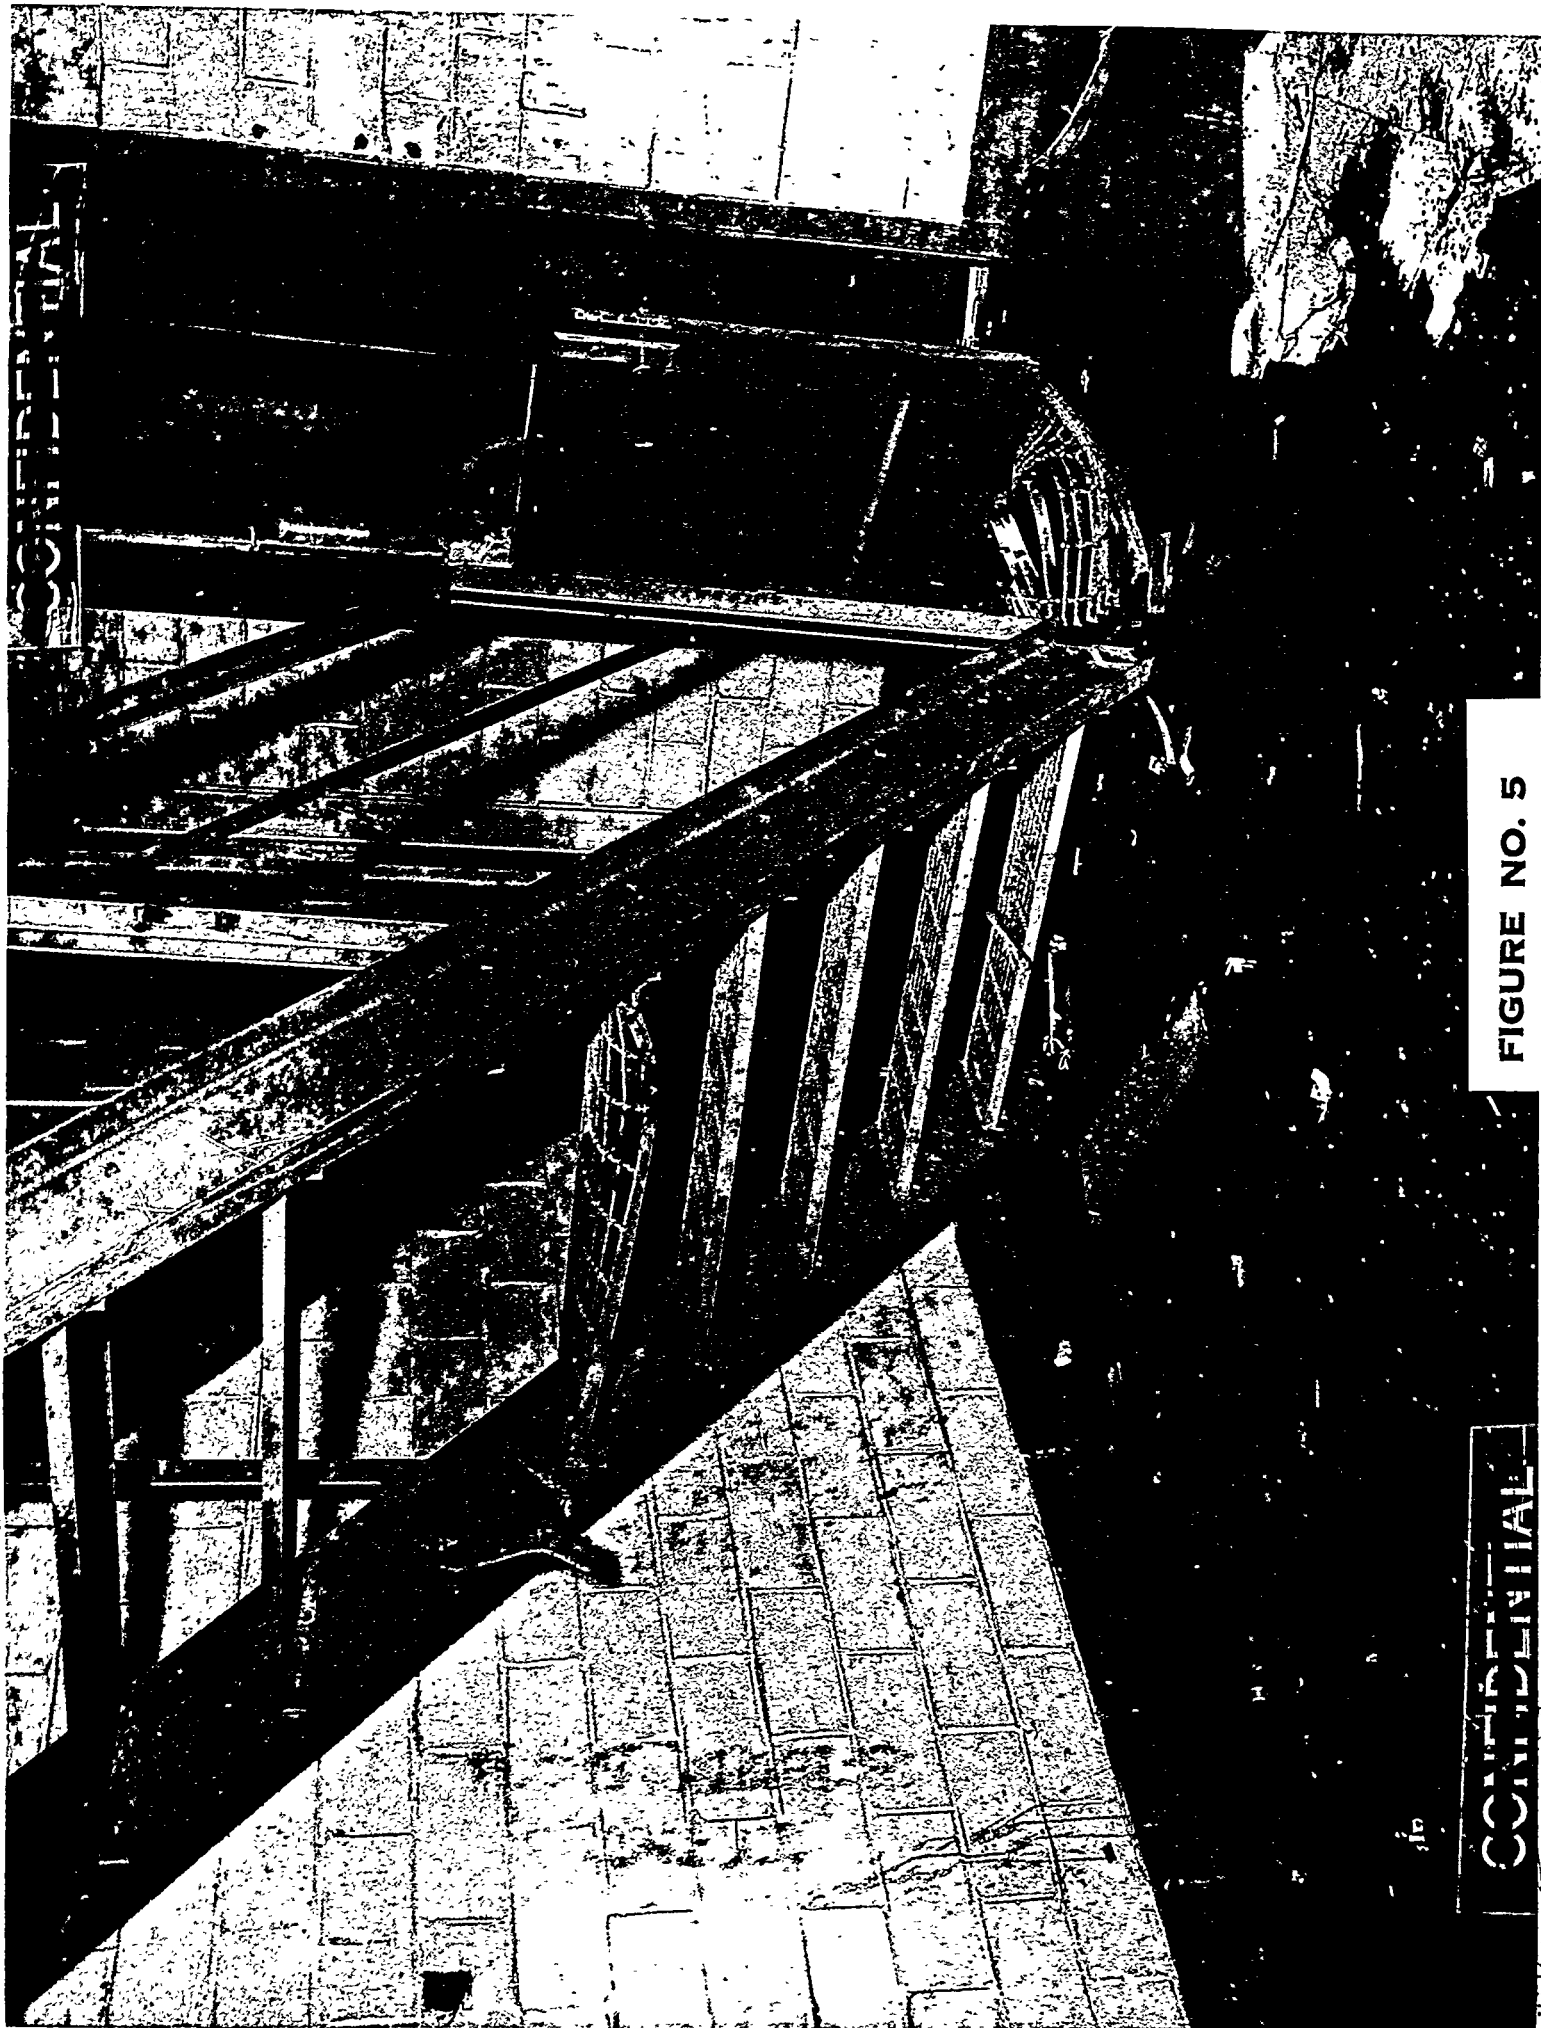
FIGURE NO. 5

- d. Photograph No. 5. Damage done to stairway by piece of metal. Metal had broken a hole in a length of cyclone fencing before striking these stairs which were about 30 ft. from the heating bath.

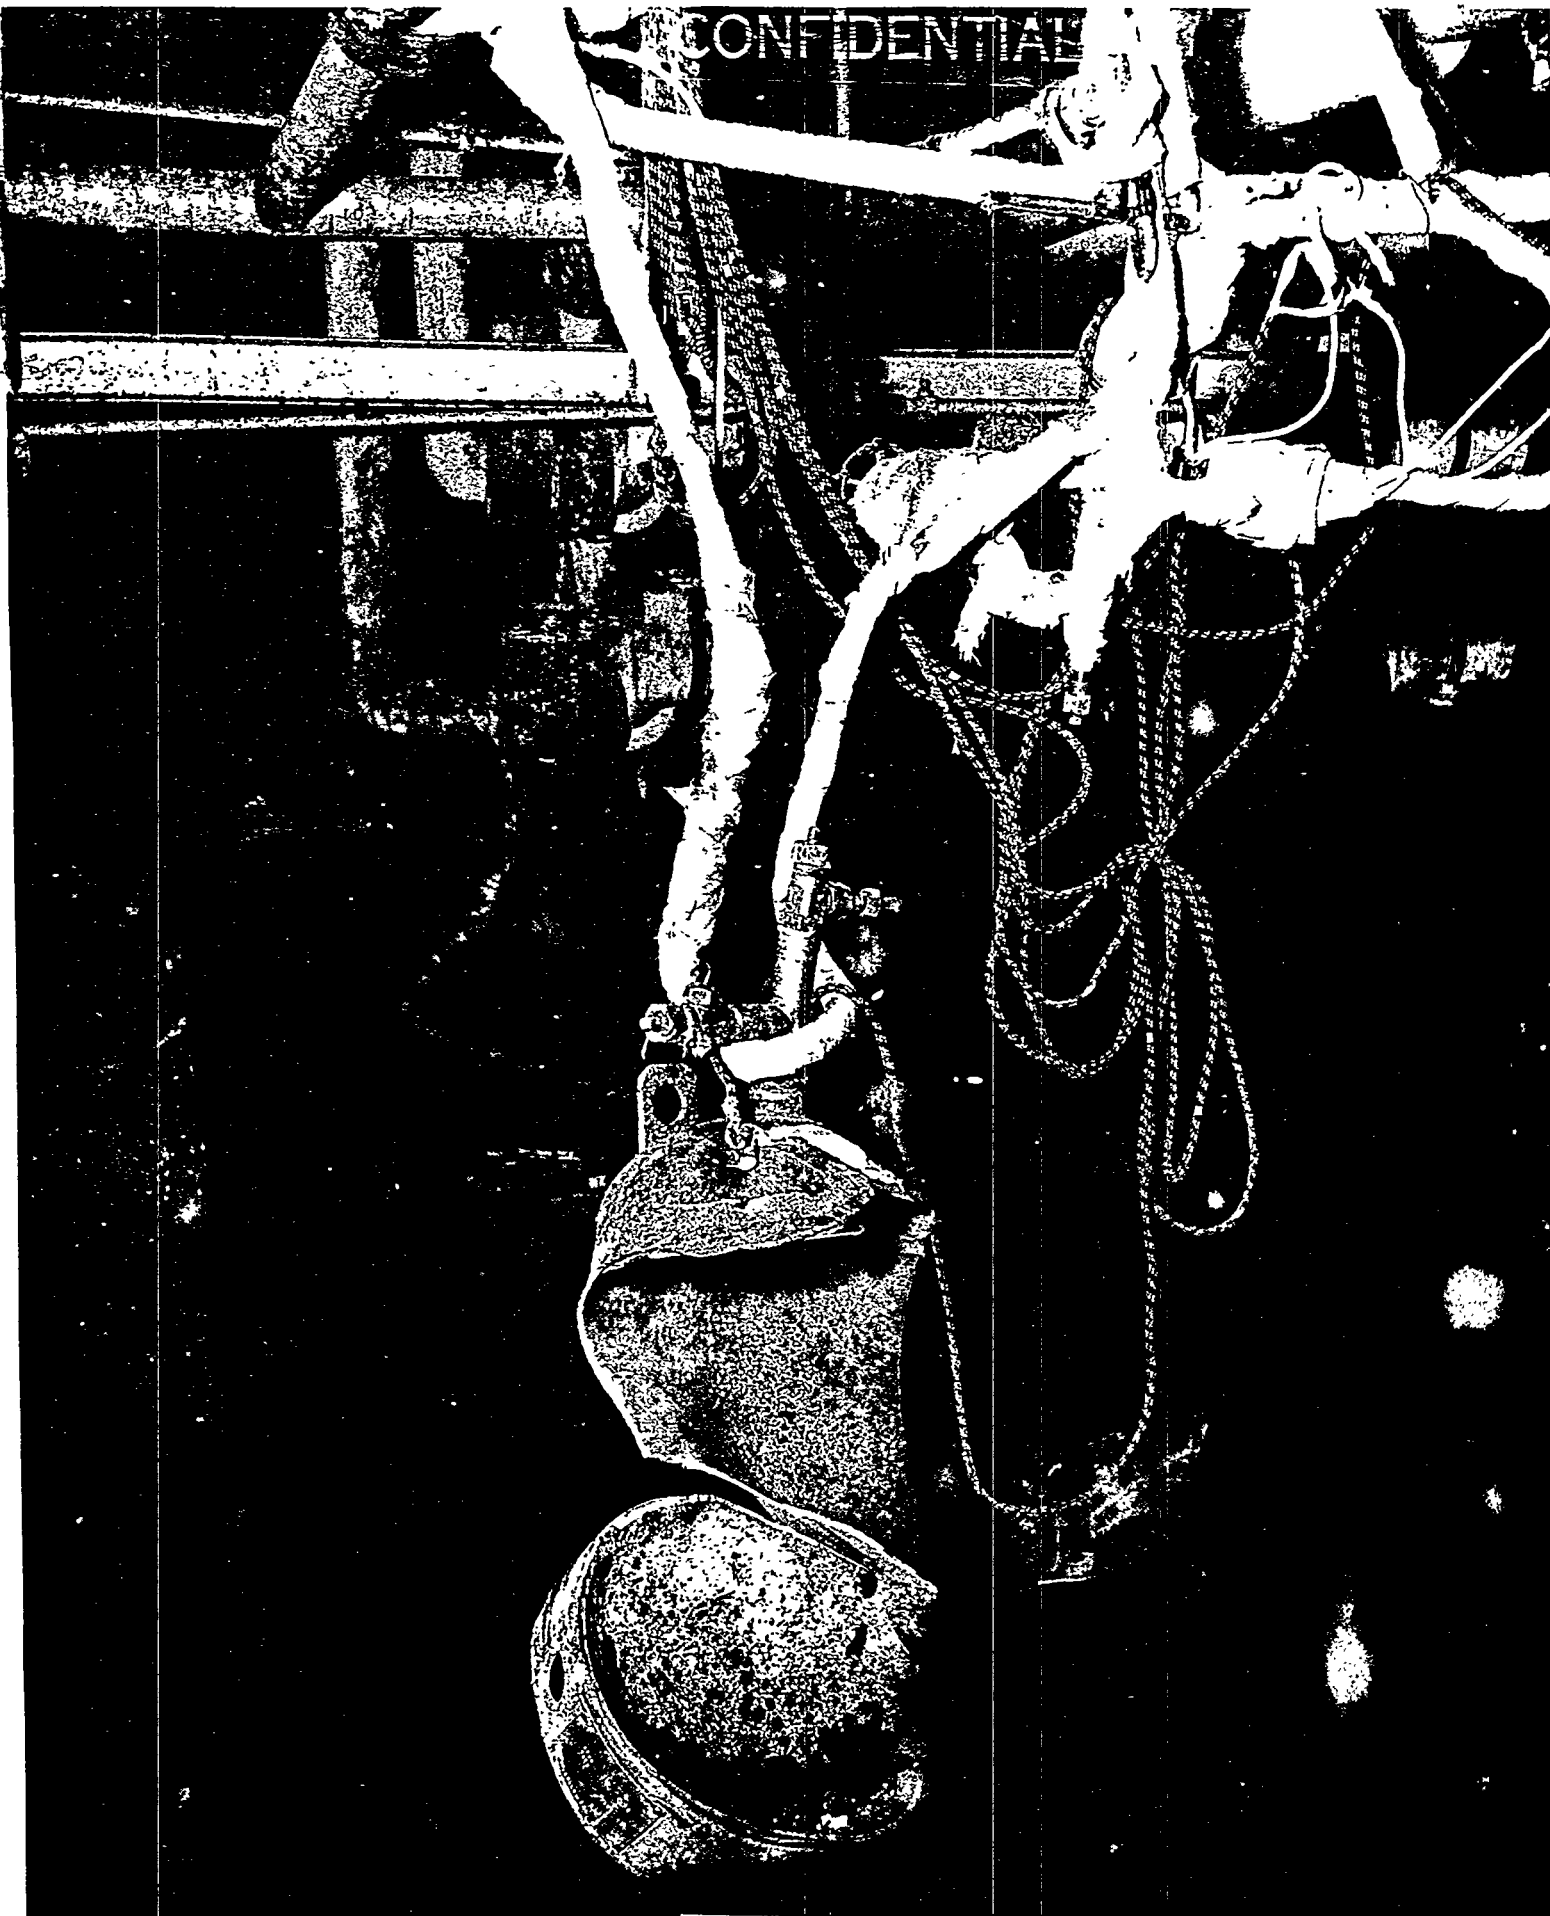
FIGURE NO. 6

- e. Photograph No. 6. Largest piece of cylinder found; it had looped itself in the insulated piping as shown.
 - f. Photograph No. 7. Damage done to transfer piping. The feed bath is also shown; the cylinder which did not explode was immediately frozen down with dry ice.
